Pre-demolition Hazardous Building Materials Survey Report

607 Cliff Avenue
Enderby, BC

August 25, 2014

Pinchin West Project No. 35758A

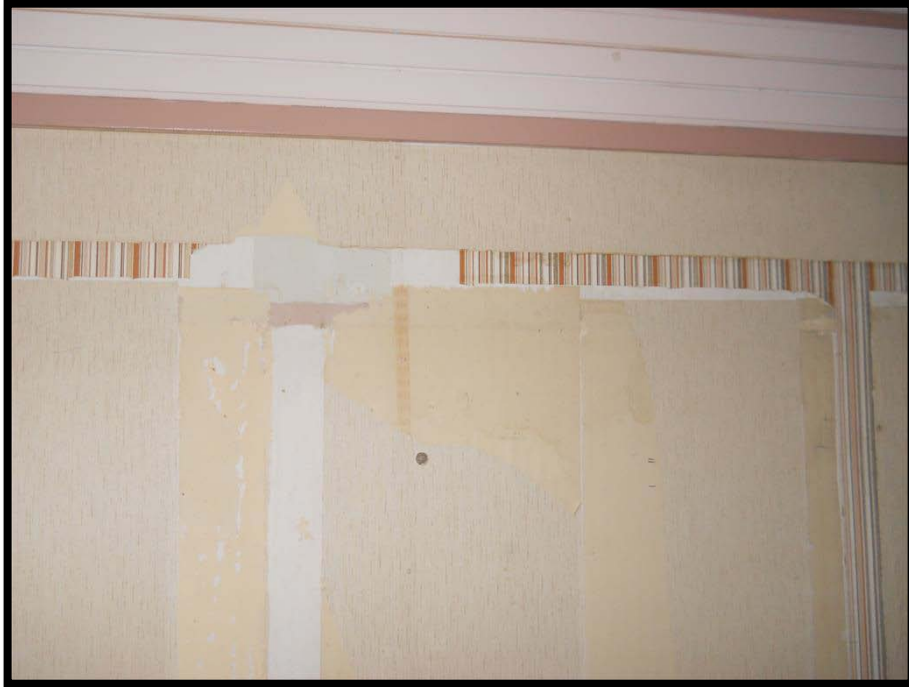
System / Material	Sample #(s); Asbestos Type (Content); Friability	Locations	Estimated Quantity
Wall: Drywall joint compound	S03A-C; Chrysotile (2%); Non-friable	Locations 1 and 2	500 ft ²
Other: Vermiculite insulation	S05A-C; Confirmed Libby Amphibole; Friable	Locations 1-3	1000 ft ²
Refer to Appendix II-A and II-B for materials determined to be non- asbestos.

Photo 1: Drywall applied with asbestos-containing drywall joint compound.

1. Asbestos-containing materials (ACM) must be removed prior to building demolition.
2. Cutting, grinding, drilling, removing, stripping or demolition of materials containing or coated with lead should be completed only with proper safety precautions which may include respiratory protection. The requirements for engineering controls and personal protective equipment must be assessed on a project by project basis.

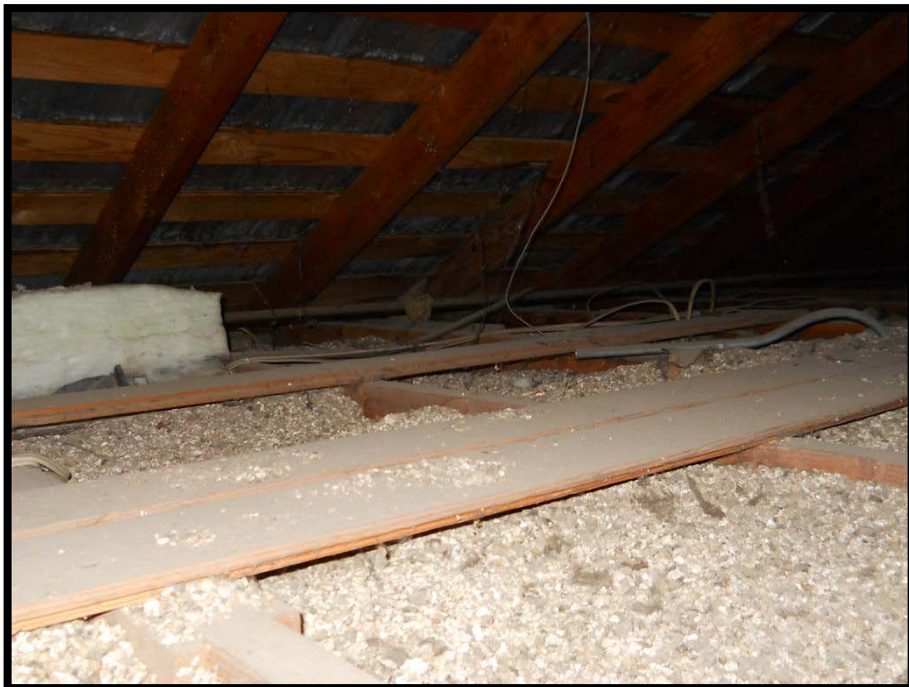
SAMPLE IDENTIFICATION	SAMPLE DESCRIPTION	% COMPOSITION (VISUAL ESTIMATE)	
		ASBESTOS	OTHER
S0005A Vermiculite insulation, loc. 3	Homogeneous, grey, beige and brown, loose particulate, micaceous material.	Libby Amphibole Asbestos	Confirmed Vermiculite > 75%
Comments:	This sample originated from Libby Montana (a mine known to be contaminated with amphibole asbestos and is sold under the brand name Zonolite) and was confirmed in our laboratory to contain asbestos fibres. The laboratory does not report a percentage due to the variable asbestos content of the vermiculite from bag to bag or even between sampling locations in the same installation. The overall percentage of asbestos in Libby Vermiculite has been shown to range up to 6% (Atkinson et al. 1982; Amandus et al. 1987). Pinchin recommends that once the material is confirmed to be Libby Zonolite, it be treated as an asbestos containing material.

Photo 2: Asbestos-containing vermiculite insulation.

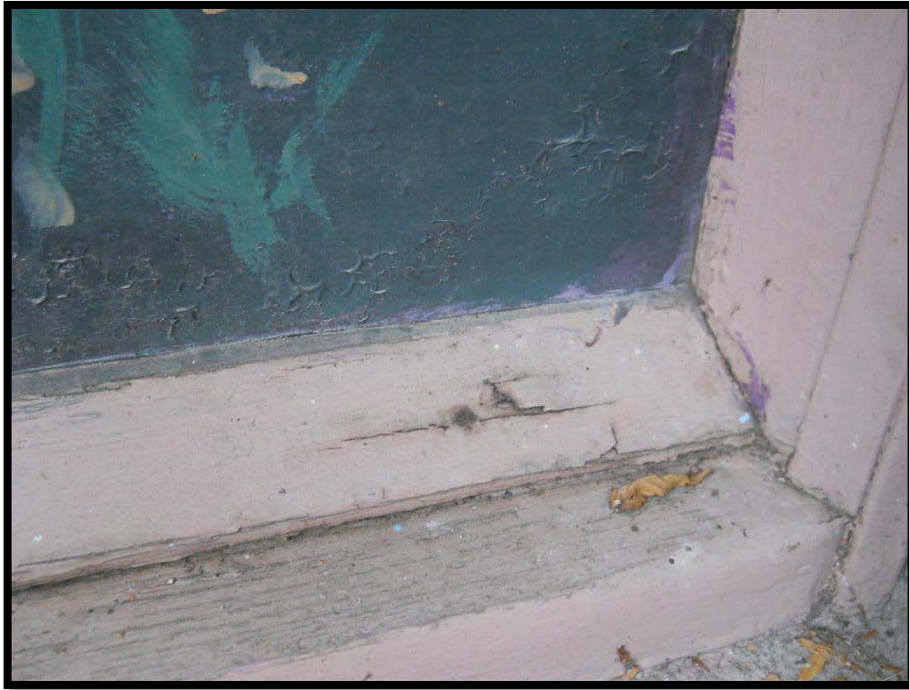
Photo 3: Lead-based brown exterior trim paint.

3. Lead-painted materials must be tested for leachable lead to determine if a hazardous waste prior to disposal.
4. Prior to demolition, remove mercury and PCBs.
5. Follow safe work procedures if cutting or grinding concrete and other items containing crystalline silica.
6. Follow safe work procedures if conducting hand demolition of mouldy materials.
7. Prepare specifications for hazardous material removal. The specifications should include and address the scope of work, safe work practices, risk assessments, personal protective equipment, respiratory protection, and disposal of waste materials.
8. Retain a qualified consultant to specify, inspect and verify the successful removal of hazardous materials.
9. Retain a qualified structural engineer to inspect the structural integrity of the building prior to beginning any work activities.

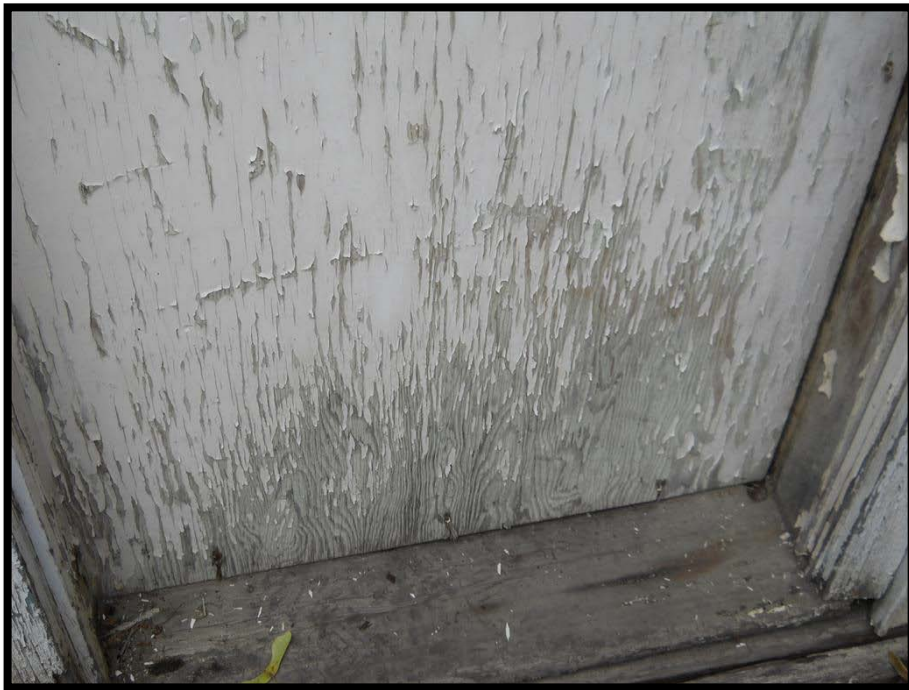
Photo 4: Lead-based white exterior/trim paint.

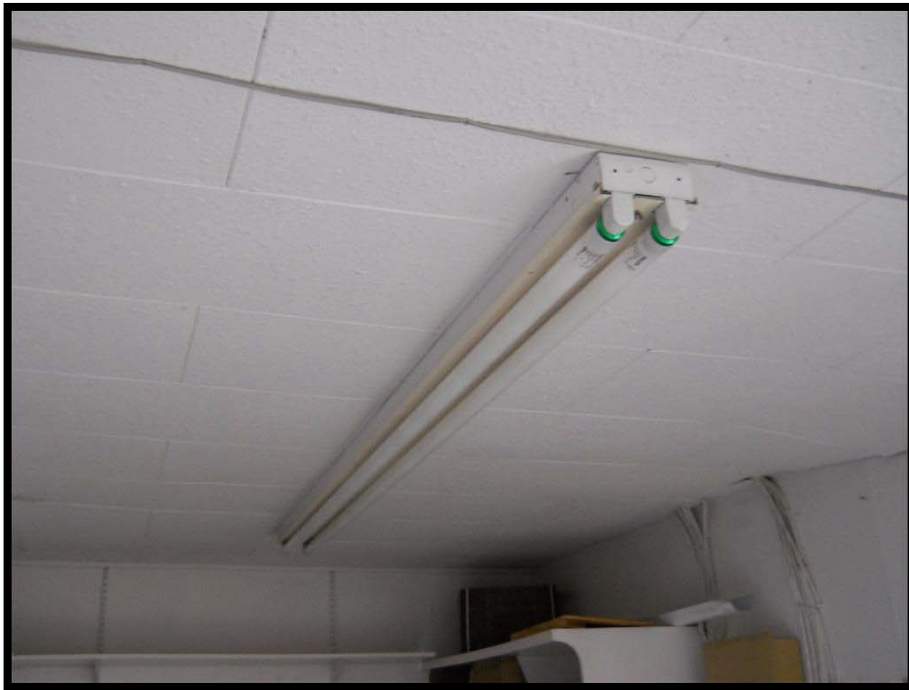
Component	Estimated Quantity	Locations
Fluorescent light tubes.	All	Location 1, 2, 6

Type	Estimated Quantity	Locations/Sample #(s)	Conclusions
Ballasts within light fixtures.	All	Location 1, 2, 6	PCB ballasts are presumed to be present based on the date of construction.
Caulking	N/A	Location 10; Sample PCB01	The caulking on the windows or control joints was sampled and does not contain PCBs.

Photo 5: Light tubes contain mercury vapour and light ballasts contains PCBs.

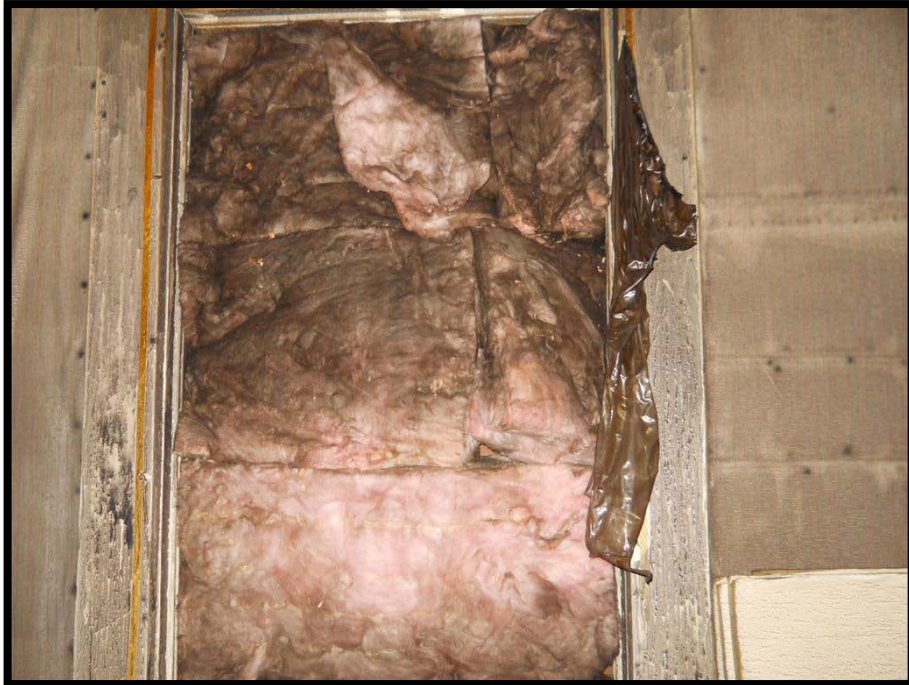
Photo 8: Visually non-asbestos fibreglass insulation.

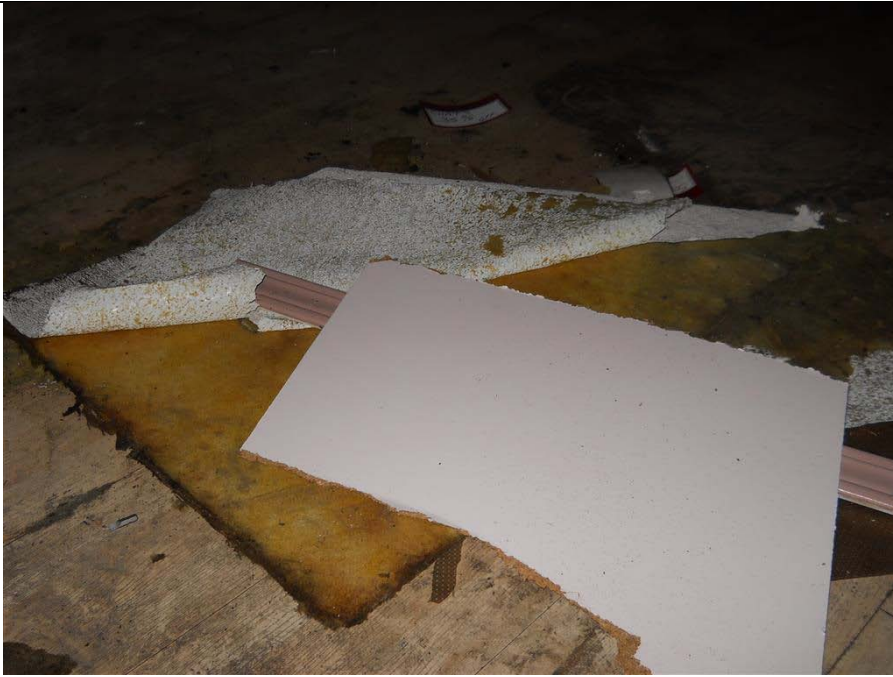
Photo 9: Visually non-asbestos fibreglass ceiling tile.
