19-0355-END-NT-PUREWAL-CHAHAL-192023-Memo _____	2
1908 George Street - sealed letter_19-444 _____	3
1908 George Street SPECS Report _____	4
1908 George Street Images _____	27

SUBJECT: 1908 GEORGE STREET – CHAHAL / PUREWAL

Structural Assessment of 1908 George Street Property

SUBJECT: Replacement Cost Value and Depreciated Construction Value Evaluation

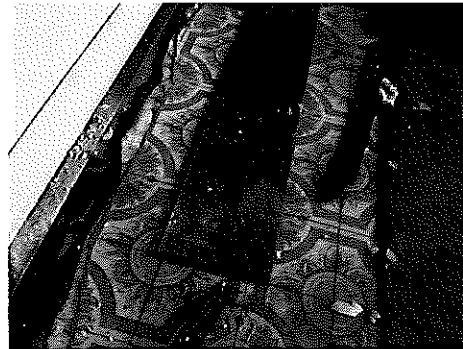
Photo 6: Dining room floor

The fire appears to have started in the Storage Area/Room directly below the kitchen and then moved into the Mechanical Room, also below the kitchen. Fire fighters gained access to the fire by taking out drywalled areas of the south and west walls of the mechanical room and east wall of the kitchen above. Additionally, some cold air returns were removed in order to access ducts during the firefighting effort, which subsequently damaged adjacent flooring and cold air return covers.

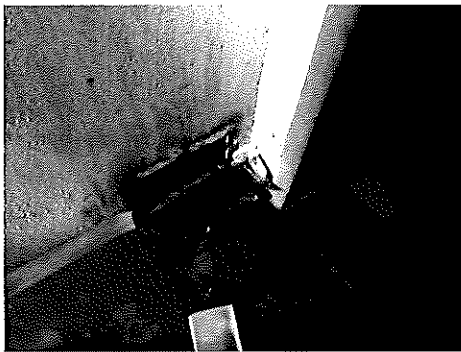
Photo 7: Firefighter damaged cold air return

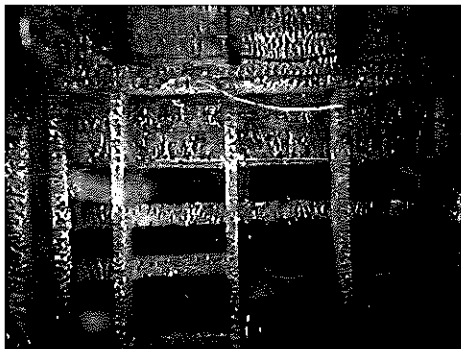
Photo 9: Fire damaged Mechanical Room

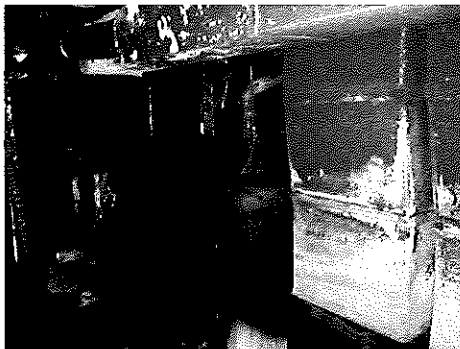
Photo 15: Fire damaged Mechanical Room

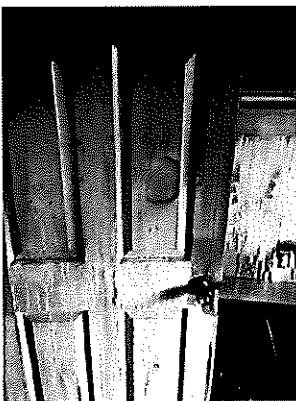
There were no closet doors on any closet in the structure with the exception of one of the hallway closets (HCL1). Doors were present on all bedroom and bathroom door openings, with the exception of Bedroom 2, however none had operational door knobs or barrel bolts as they appear to have been damaged prior to the loss. Bedroom 4 had a door that did not fit the opening, where the hinges for the door slab were attached directly to the face of the door opening casings.

Photo 17: Bedroom 5 door damage

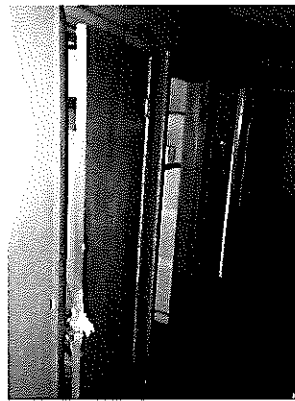
Photo 18: Hall closets missing/damaged doors

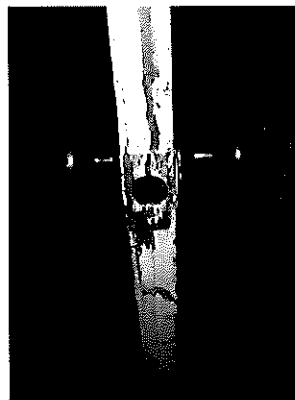
Photo 20: Bathroom door damage

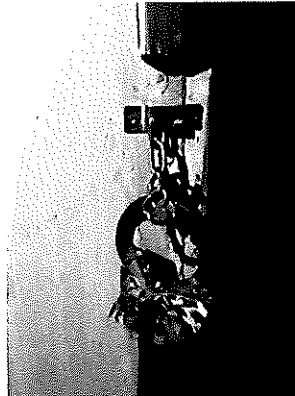
Photo 22: Bedroom 2 door lock

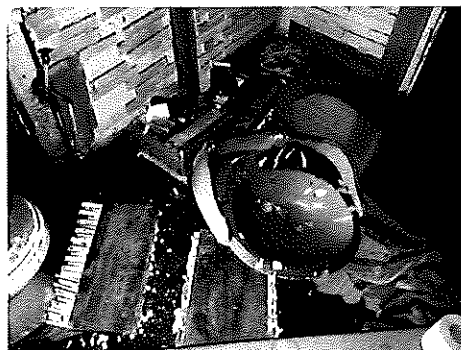
The bathroom on the main level had the toilet detached along with a sink (sitting on the floor), the vanity was missing, it appears that the bathroom may have been under renovation.

Photo 24: Bathroom sink on floor/missing vanity

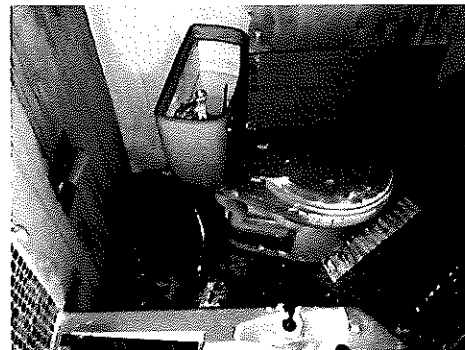
Photo 25: Bathroom toilet detached

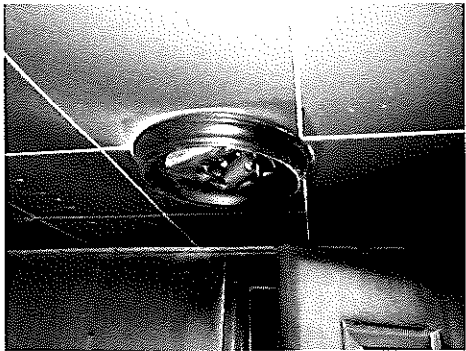
Many light fixtures were detached, missing, or had no bulbs.

Photo 28: Fixture missing glass and bulbs

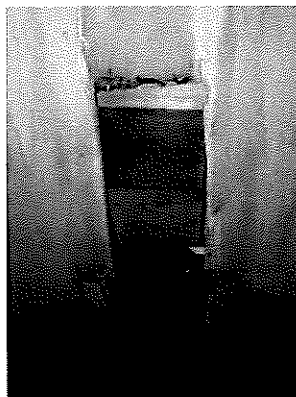
There were several holes in the walls and ceilings throughout the structure that do not appear to be associated with the loss. A hole had been cut in the wall between Bedroom 2 and the closet of Bedroom 3 (B3CL) and an attempt to cover the hole was done with a shelf turned on end and hinged to the wall, creating a discreet access to Bedroom 2 from B3CL. There were numerous wood blocks fastened to walls and door jambs, serving no apparent purpose.

Photo 29: Plumbing access cut in wall

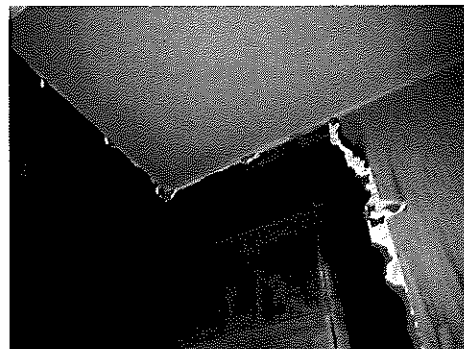
Photo 30: Bedroom 1 closet missing drywall

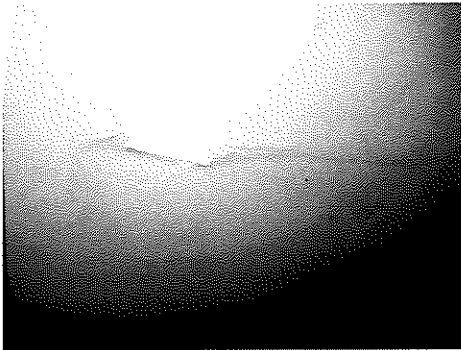
Photo 33: Damaged ceiling

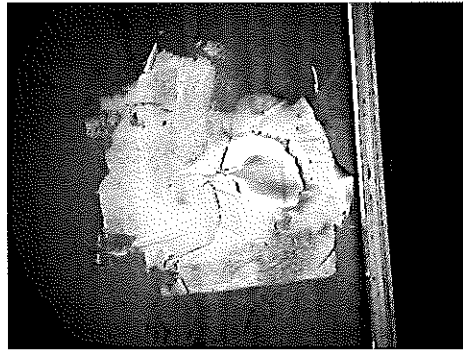
Photo 34: Damaged wall

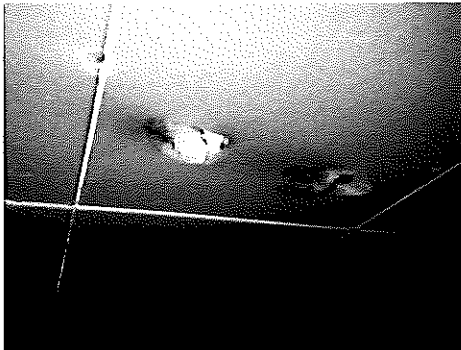
Photo 35: Damaged ceiling

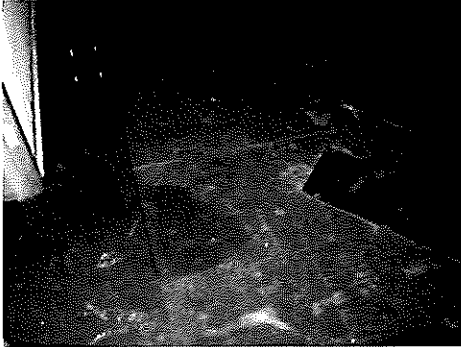
Bedroom 1 had vinyl tile flooring installed to approximately 80% of the floor area. Bedroom 2 had laminate flooring installed on the south side of the room only, covering approximately 60% of the room's floor area. Bedroom 3 had vinyl tile installed to approximately 60% of the floor area with sub floor visible for the remainder. No loose or boxed supplies to finish the flooring installation were found on site.

Photo 37: Incomplete flooring

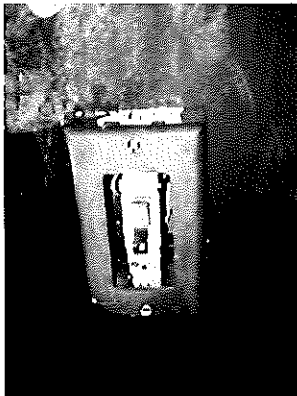
There were several observed electrical hazards with many missing or incorrectly installed outlets, switches and covers throughout the structure. Some plugs had signs of substantial overuse/age, likely well beyond design life and should have been replaced.

Photo 38: Incorrect switch cover

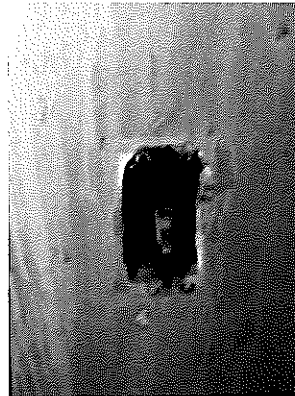
Photo 39: Missing switch cover

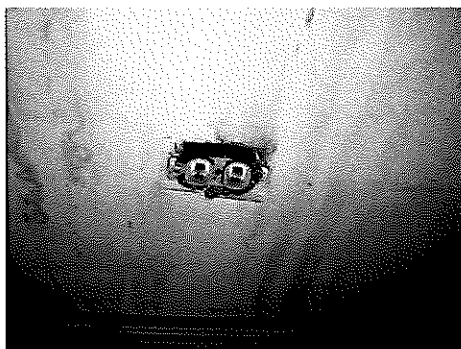
Photo 40: Worn receptacle without cover
