BOARD OF VARIANCE MEETING AGENDA

DATE: September 15, 2020
TIME: 3:00 p.m.
LOCATION: Enderby City Hall

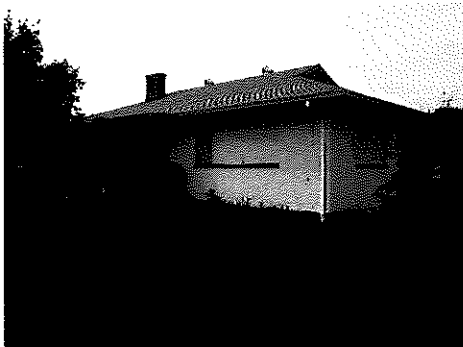
Photo 1: North and West elevation

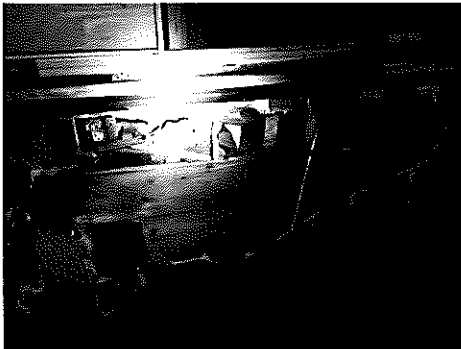
Photo 5: Firefighter damage Kitchen wall

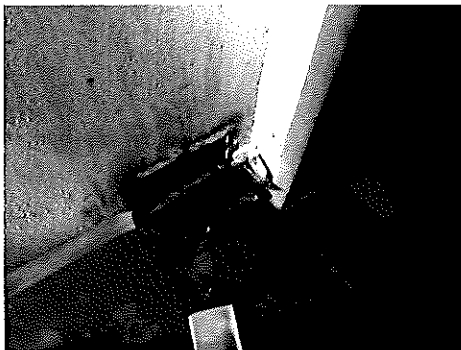
Photo 7: Firefighter damaged cold air return

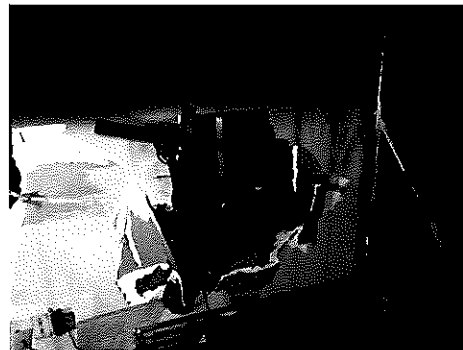
Photo 8: Firefighter damage Mechanical Room wall

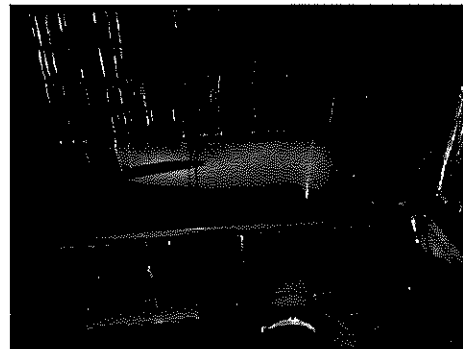
Photo 10: Basement Bathroom 2

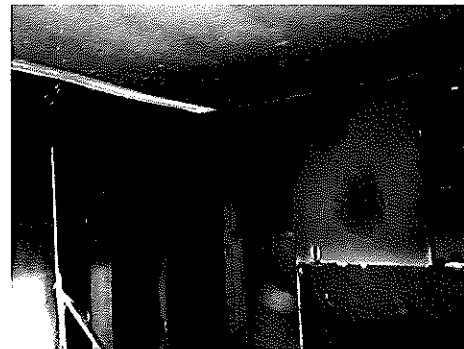
Photo 16: Recreation Room

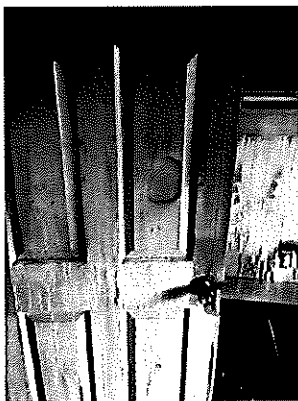
Photo 17: Bedroom 5 door damage

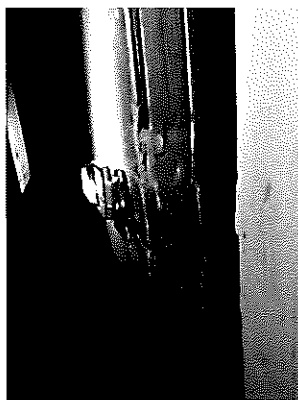
Photo 19: Bedroom 1 damaged door

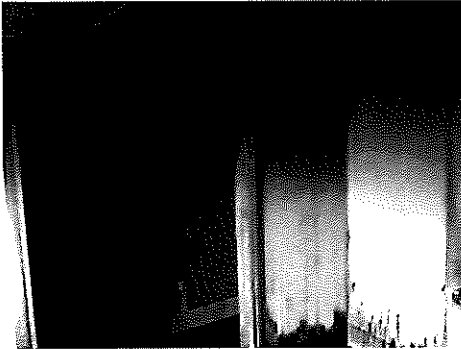
Photo 21: Bedroom 5 missing closet doors

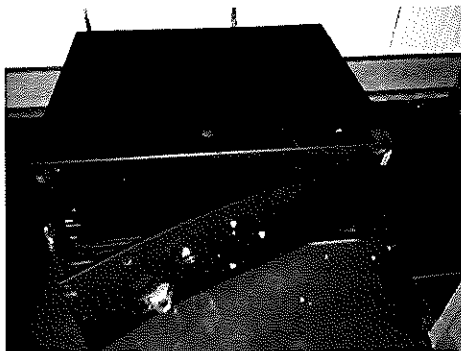
Photo 23: Lockbox Bedroom 2

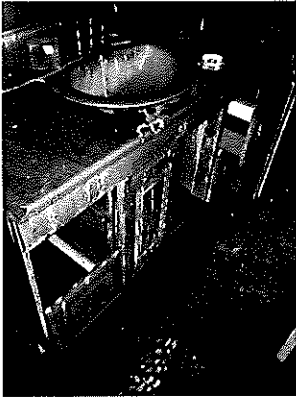
Photo 26: Bathroom 2 vanity/missing doors

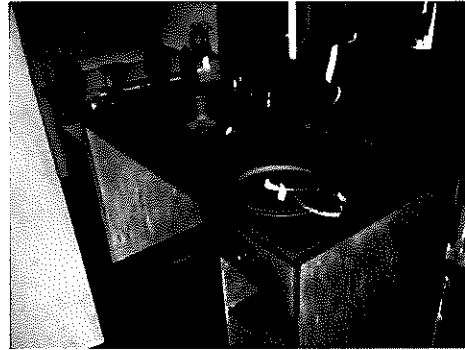
Photo 27: Kitchen 2 cabinets missing doors/drawers

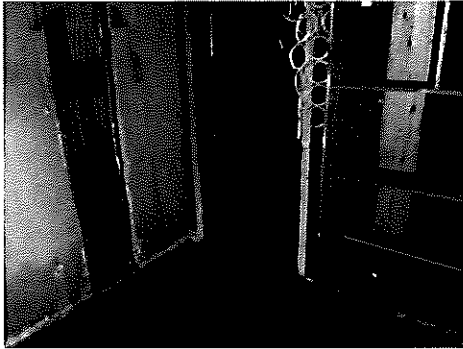
Photo 31: Bedroom 2 access to B3CL

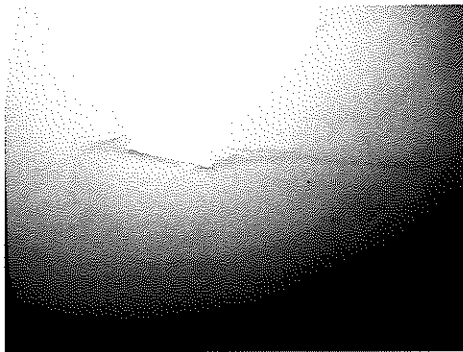
Photo 33: Damaged ceiling

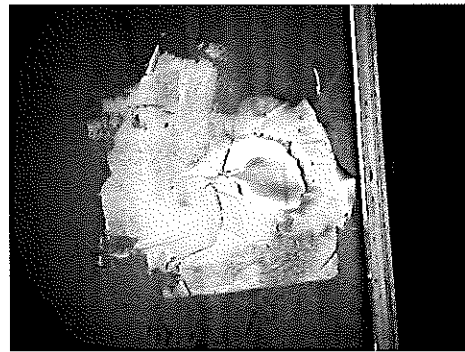
Photo 34: Damaged wall

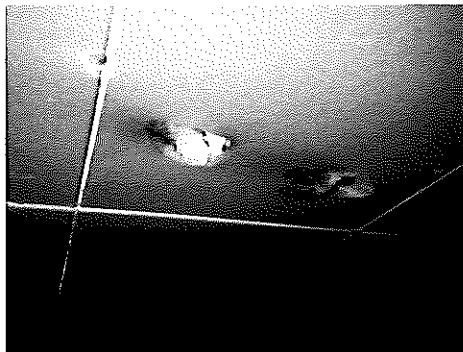
Photo 35: Damaged ceiling

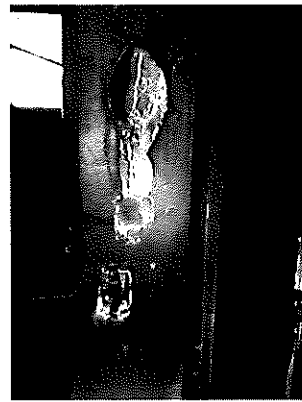
Photo 36: Damaged wall/missing cover

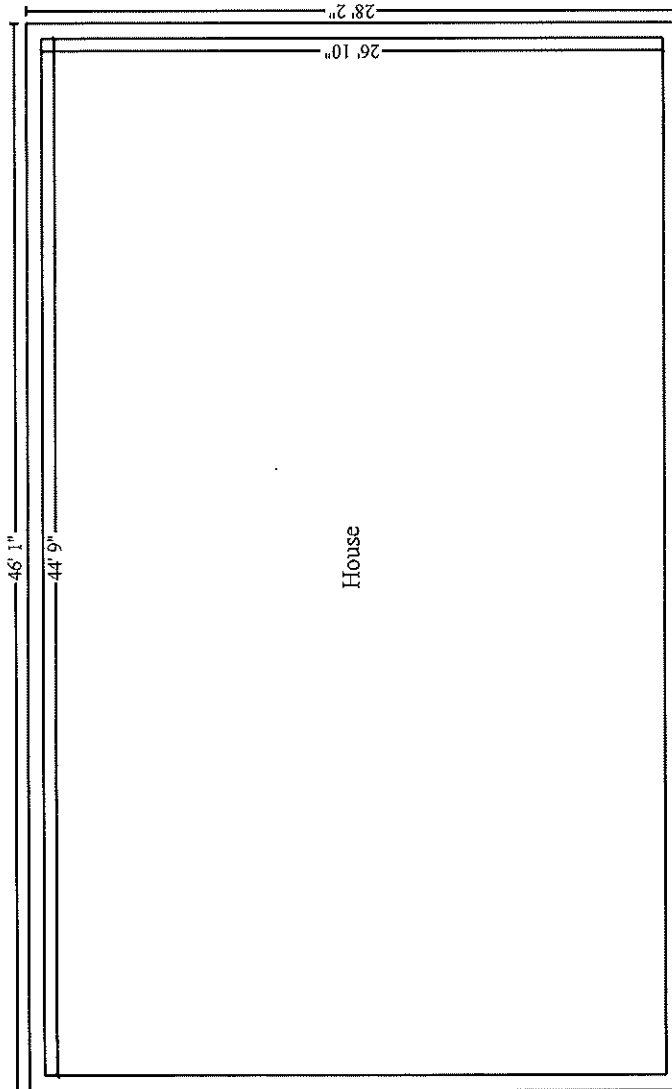
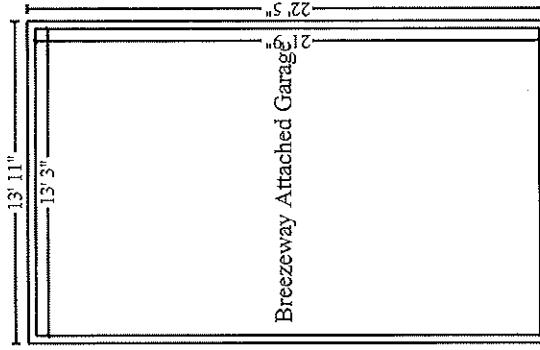
RCV Total	\$ 264,227.62	
Depreciation	\$ 131,260.30	
DCV Total	\$ 132,967.32	
Total Depreciation %	50%
